# Manhole Inspection Summary

Manhole # S21K\_\_010MH

Insp Date: **4/3/08 2:24 PM**

**Location** Address: **302 s fulton st**

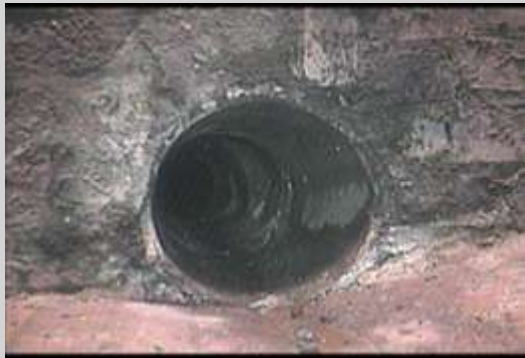
12 O'Clock Outflow

8 in. Circular Gravity Sewer  
Pipe Out @ 12 O'Clock

Infiltration: **None** Pipe Seal Cond: **Sound**
